EXHIBIT A:
FBS Joint Storm Damage Report

Joint Storm Damage Report

**Forest Ridge Homeowners Association
1551 Yellowstone Drive**

FIELD REPORT FOR INITIAL STORM DAMAGE INVESTIGATION

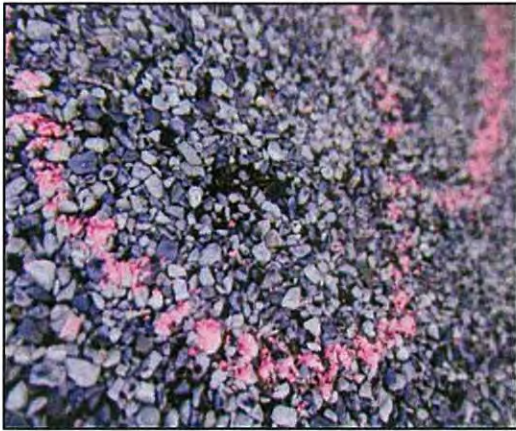
Figure 1.

- Impact damage to window screens.
- Impact damage to gutter.
- Missing shingle tab.
- 20+ impacts identified on the south facing roof slope.
- 20+ impacts identified on the north facing roof slope.

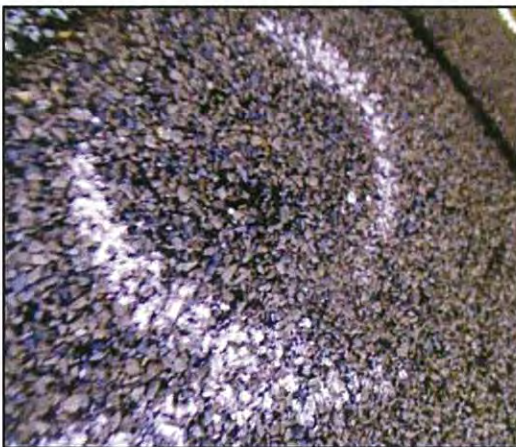
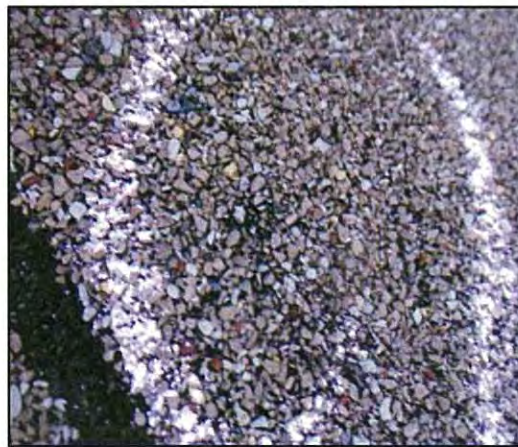
- Impact damage to vinyl siding.
- 20+ impacts identified on the south facing roof slope.
- 20+ impacts identified on the north facing roof slope.
- This building also inspected a 2nd time, on November 9, 2017 by Tom Irmiter.
 - The following observations were made at that time:
 - Front Center area: 10+ impacts from hail.
 - Back: 12+ impacts from hail.
 - Siding pulled back: No manufacturer identifying marks found.
 - Siding in contact with roofing.

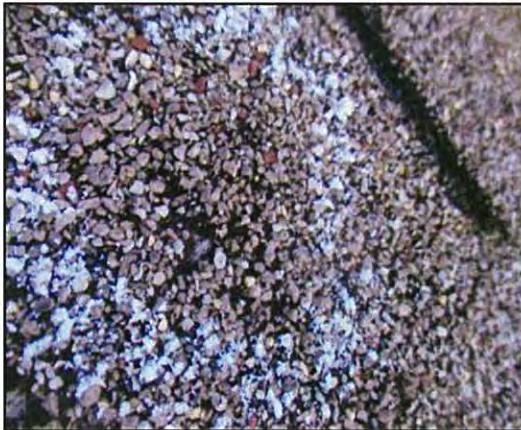
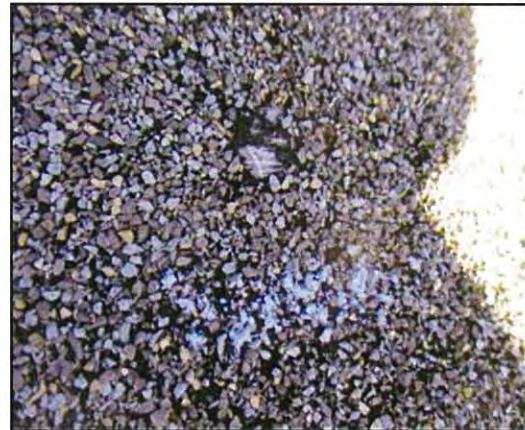
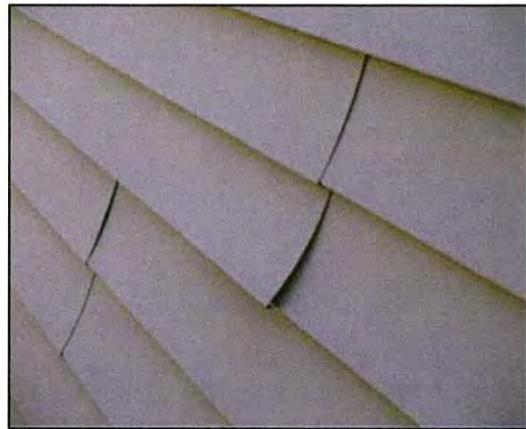
- This building inspected on October 16, 2017 by Brian Johnson, P.E. and Kevin Steinke. The following observations were made at that time.
- Impact damage to gutter and downspouts.
- Impact damage to metal light fixture (see fig. 10 of photo log).
- Impact damage to vinyl siding.
- Detached vinyl siding identified.
- Small part of roof tarped over.
- Missing shingle tab.
- 20+ impacts identified on the south facing roof slope.
- 20+ impacts identified on the north facing roof slope.

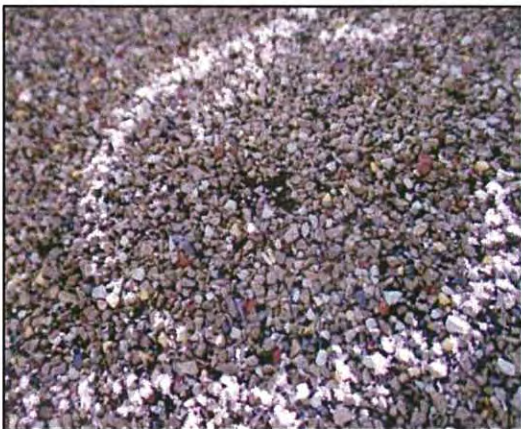
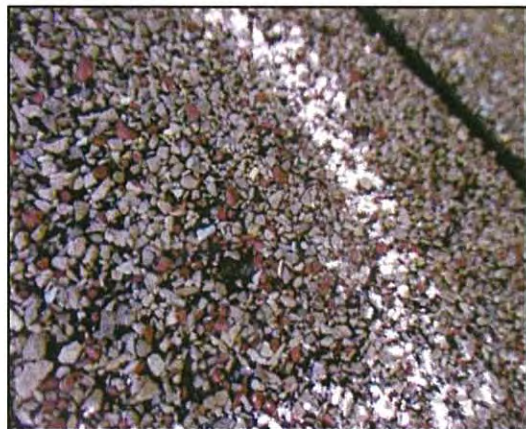
- Impact damage to vinyl siding.
- Impact damage to gutter.
- 20+ impacts identified on the east facing roof slope.
- 20+ impacts identified on the west facing roof slope.

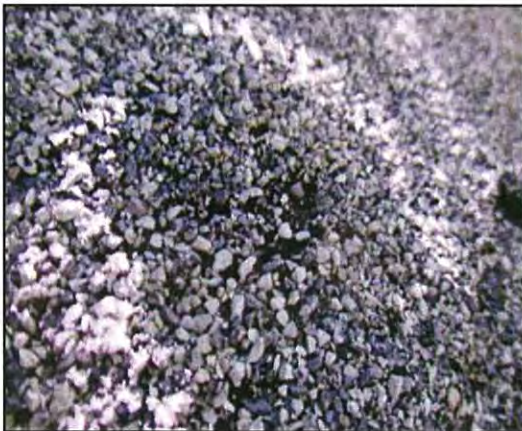
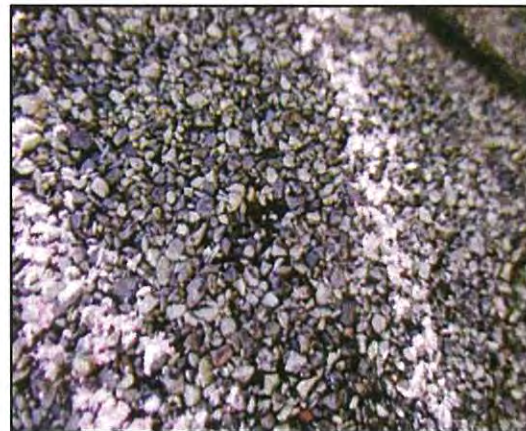
- Impact damage to gutter and downspout.
- Buckling of the roof deck was observed.
- Tarped off section of roof slope observed.
- Impact damage to drip cap above window.
- 20+ impacts identified on the southeast facing roof slope.
- 20+ impacts identified on the northwest facing roof slope.
- This building also inspected a 2nd time, on November 9, 2017 by Tom Irmiter.

- Front: 7 impacts from hail in a 5 x 10 area
- Back: 13 impacts from hail in a 5 x 10 area
- Tarp on part of roof
- Mechanical – Foot traffic damage on front
- Visible nail at one location
- 1-inch spatter on concrete window sills, Telecom. Equipment,
- Chips on decking
- Siding damage on right elevation
- Downspout damage

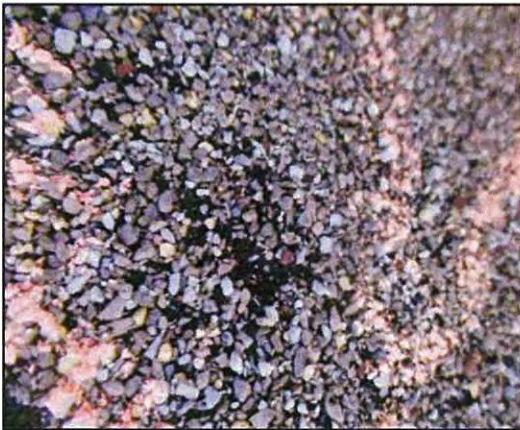
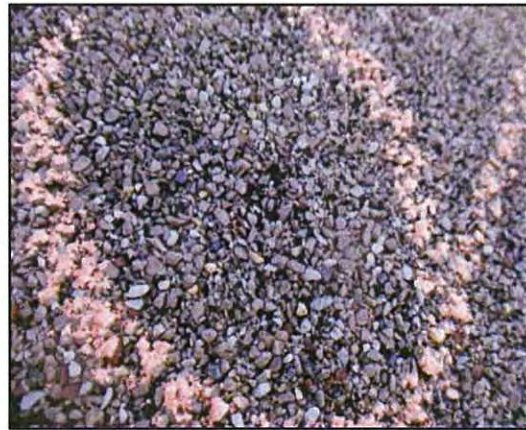
- Impact damage to gutter and downspouts.
- Detached vinyl siding identified.
- Mechanical damage to shingle identified.
- 20+ impacts identified on the southwest facing roof slope.
- 20+ impacts identified on the northeast facing roof slope.

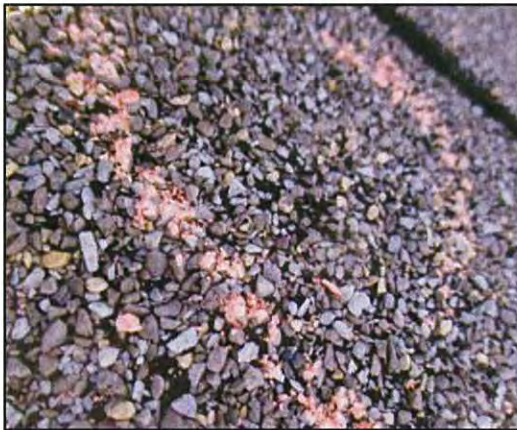
Figure 21.

- Impact damage to gutter.
- 20+ impacts identified on the south facing roof slope.
- 20+ impacts identified on the north facing roof slope.

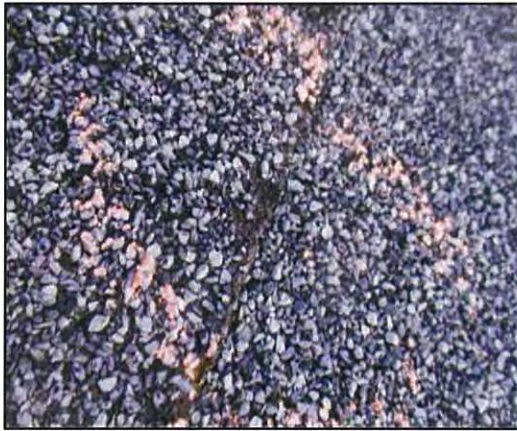
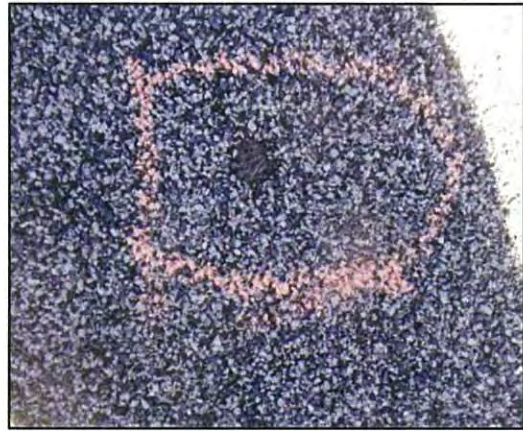
- Minimal impact damage to A/C condenser coils.
- Impact damage to gutter and downspouts.
- Improperly driven fastener identified.
- Mechanical damage to shingle identified.
- 12 impacts identified on the northwest facing roof slope.
- 7 impacts identified on the southeast facing roof slope.

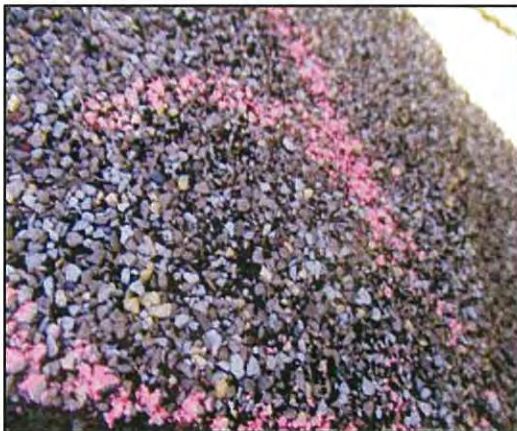
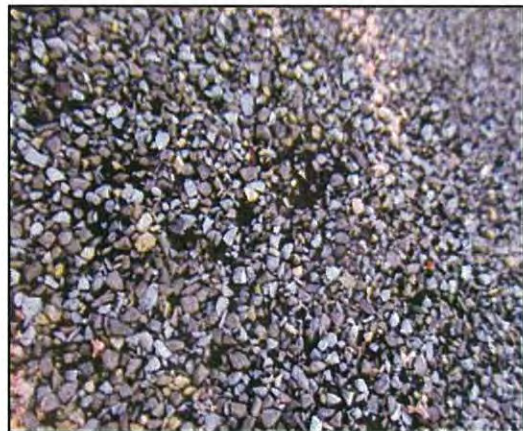
- Impact damage to gutter.
- Part of roof tarped over.
- Mechanical damage to shingle identified.
- 20+ impacts identified on the southeast facing roof slope.
- 20+ impacts identified on the northwest facing roof slope.

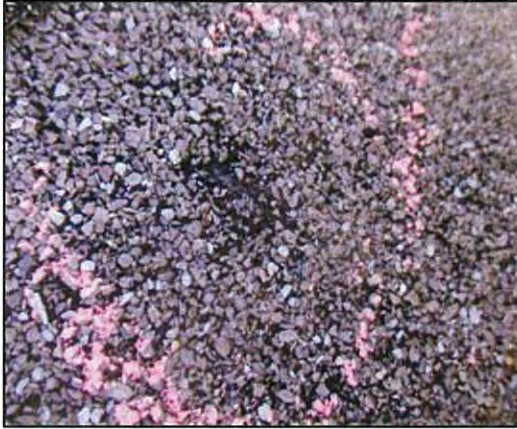
Figure 28.

- Impact damage to gutter.
- Improperly driven fastener identified.
- 20+ impacts identified on the southeast facing roof slope.

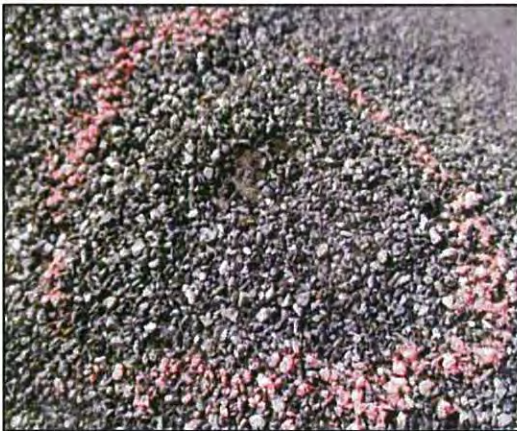
Figure 30.

- This building inspected on October 16, 2017 by Brian Johnson, P.E. and Kevin Steinke. The following observations were made at that time:
- Minimal impact damage to A/C condenser coils.
- Impact damage to gutter and downspouts.
- Impact damage to vinyl siding.
- Part of roof tarped over.
- 13 impacts identified on the northwest facing roof slope.
- 20 impacts identified on the southeast facing roof slope.

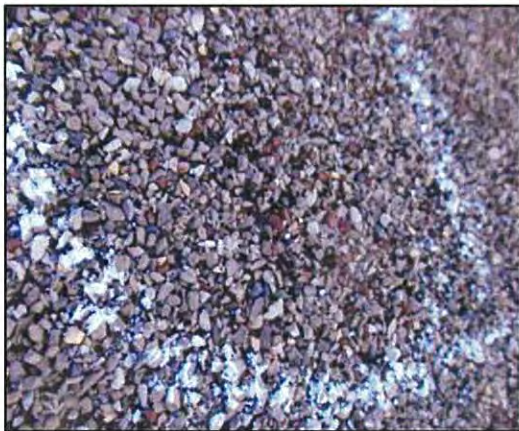
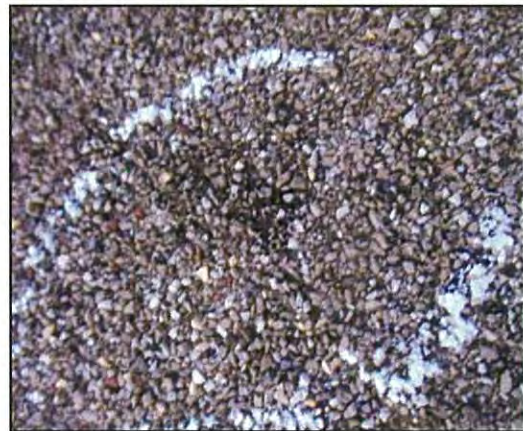
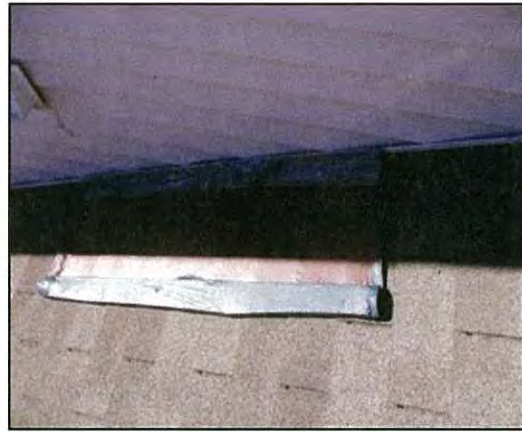
- Minimal impact damage to A/C condenser coils.
- Impact damage to gutter.
- Parts of roof tarped over.
- Missing shingle tabs identified.
- Mechanically damaged shingle identified.
- 20+ impacts identified on the southwest facing roof slope.
- 17 impacts identified on the northeast facing roof slope.

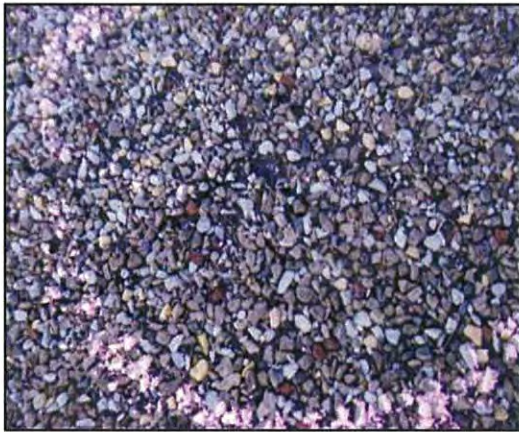
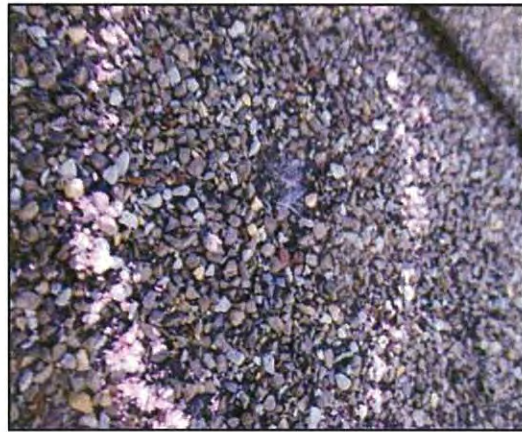
- Impact damage to gutter.
- Part of roof tarped over.
- Missing shingle tabs identified.
- Mechanically damaged shingle identified.
- 20+ impacts identified on the west facing roof slope.
- 20+ impacts identified on the east facing roof slope.

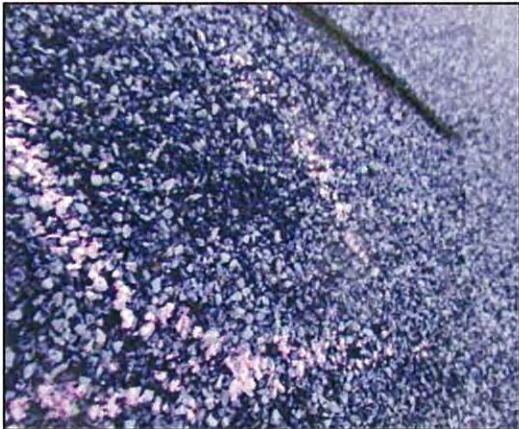
Figure 41.

- Impact damage to vinyl siding.
- Impact damage to gutter.
- Part of roof tarped over.
- Differing shingle appearance (possibly weathering) on half of the building.
- Mechanically damaged shingle identified.
- 13 impacts identified on the east facing roof slope.
- 15 impacts identified on the west facing roof slope.

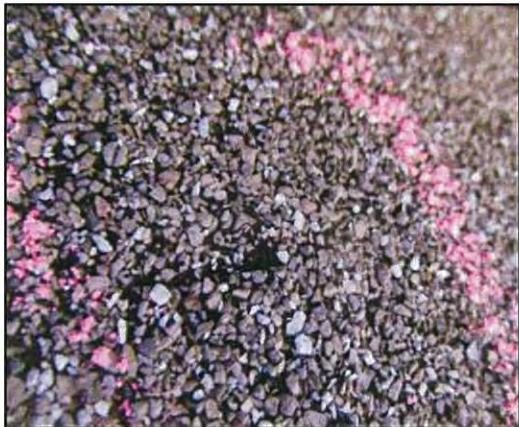
Figure 45.

- Impact damage to gutter.
- Minimal impact damage to A/C condenser coils.
- Mechanically damaged shingle identified.
- 20+ impacts identified on the west facing roof slope.
- 20+ impacts identified on the east facing roof slope.

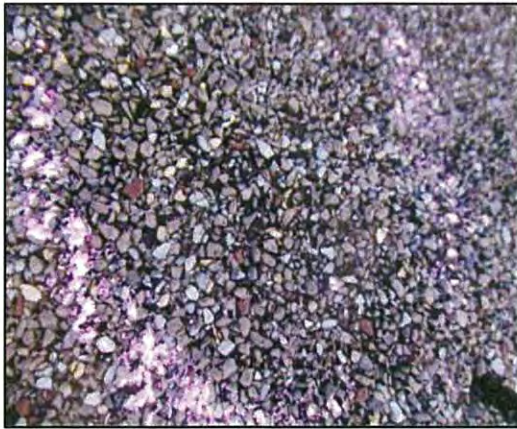
Figure 47.

- Impact damage to vinyl siding.
- Impact damage to gutter.
- Missing shingle tab identified.
- Roof tarped over in a few areas.
- Mechanically damaged shingle identified.
- 17 impacts identified on the northeast facing roof slope.
- 20+ impacts identified on the southwest facing roof slope.

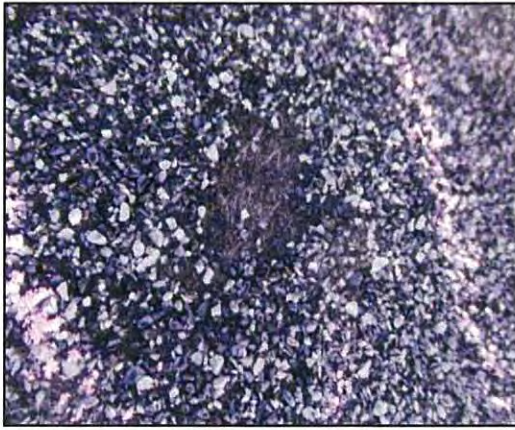
Figure 51.

- Impact damage to gutter.
- Newer shingles observed on half of the building.
- Mechanically damaged shingle identified.
- Nail pop identified.
- 7 impacts identified on the northwest facing roof slope.
- 7 impacts identified on the southeast facing roof slope.

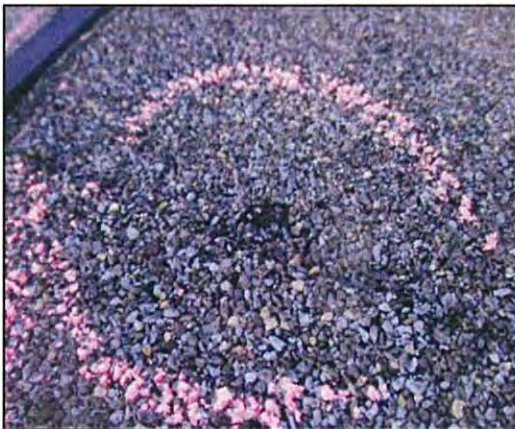
Figure 53.

- Impact damage to gutter.
- Roof tarped over in a few areas.
- Missing shingle tabs identified.
- Mechanically damaged shingle identified.
- Nail pop identified.
- 20+ impacts identified on the east facing roof slope.
- 20+ impacts identified on the west facing roof slope.

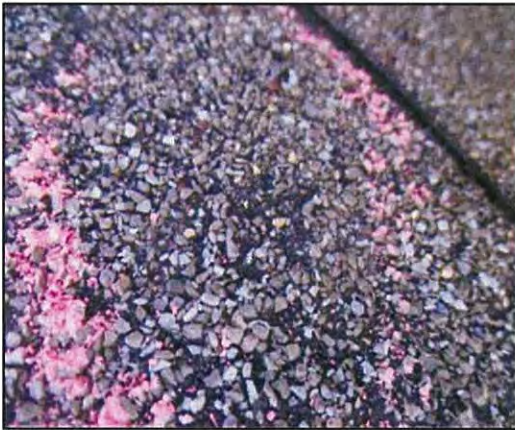
Figure 57.

- Impact damage to gutter and downspouts.
- Creased shingle tabs identified.
- 20+ impacts identified on the southwest facing roof slope.
- 9 impacts identified on the northeast facing roof slope.

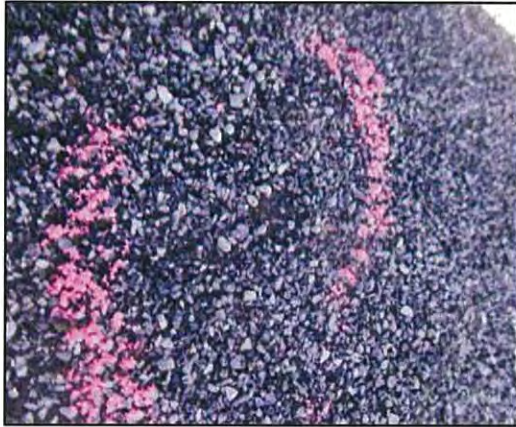
Figure 60.

- Impact damage to vinyl siding.
- 11 impacts identified on the northeast facing roof slope.
- 17 impacts identified on the southwest facing roof slope.

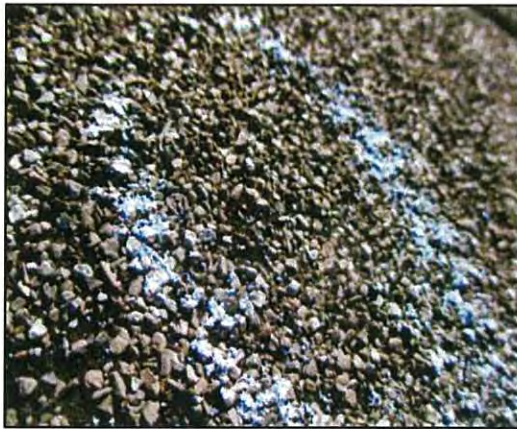
Figure 63.

- Impact damage to gutter.
- Roof tarped over in one area.
- Missing shingle tab identified.
- 20+ impacts identified on the southwest facing roof slope.
- 20+ impacts identified on the northeast facing roof slope.

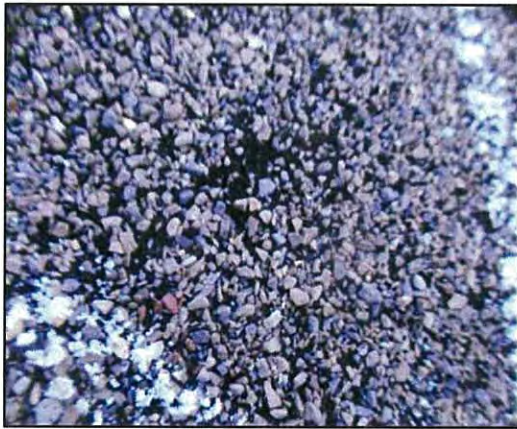
Figure 66.

- Impact damage to gutter and downspouts.
- Minimal impact to A/C condenser coils.
- Impact damage to vinyl siding.
- Creased shingles identified.
- Detached vinyl siding around window framing.
- 20+ impacts identified on the northeast facing roof slope.
- 20+ impacts identified on the southwest facing roof slope.

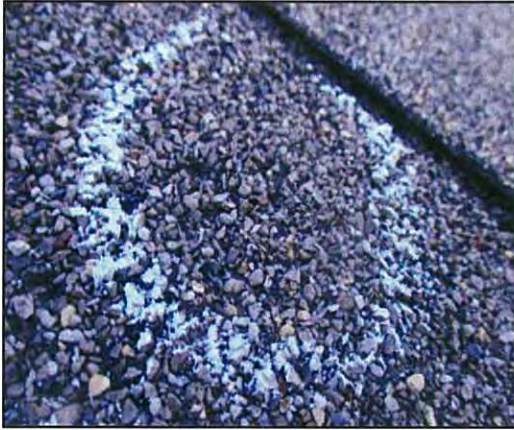
Figure 71.

- Impact damage to gutter and downspouts.
- Minimal impact to A/C condenser coils.
- Nail pop identified.
- 20+ impacts identified on the northeast facing roof slope.

- 20+ impacts identified on the southwest facing roof slope.

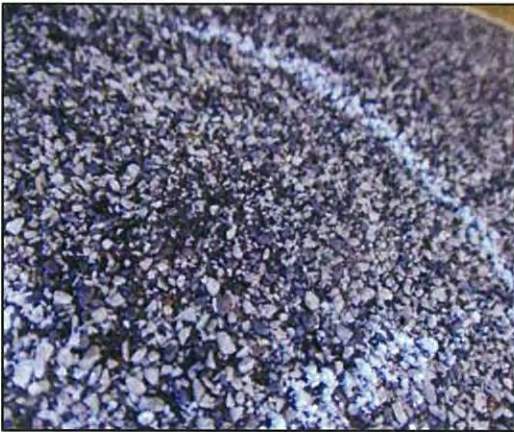
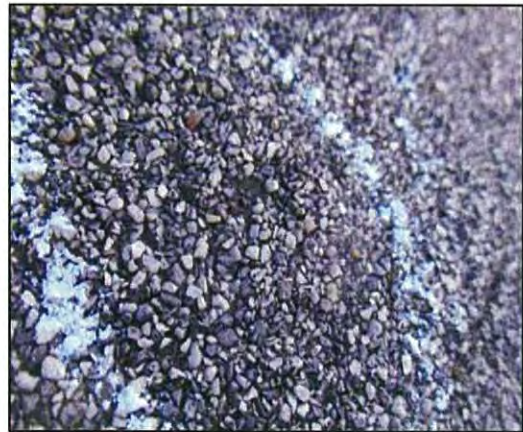
- Impact damage to gutter.
- Mechanically damaged shingle identified.
- 20+ impacts identified on the southeast facing roof slope.
- 12 impacts identified on the northwest facing roof slope.

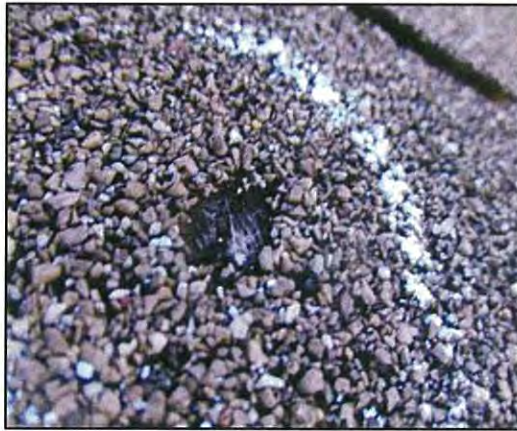
Figure 75.

- Impact damage to gutter.
- Mechanically damaged shingle identified.
- 20+ impacts identified on the northwest facing roof slope.
- 20+ impacts identified on the southeast facing roof slope.

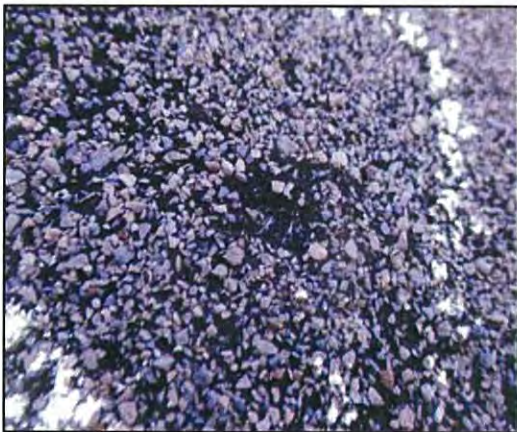
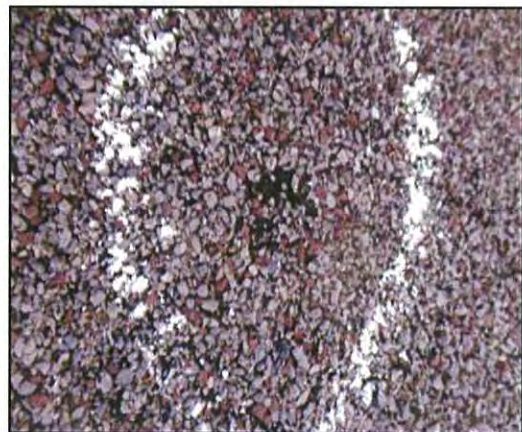
- Impact damage to downspout.
- Minimal impact damage to A/C condenser coils.
- Nail pop identified.
- Mechanically damaged shingle identified.
- 20+ impacts identified on the northeast facing roof slope.
- 20+ impacts identified on the southwest facing roof slope.

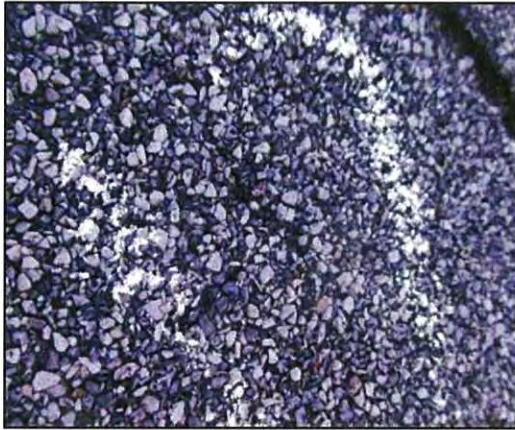
Figure 79.

- Impact damage to gutter.
- Minimal impact damage to A/C condenser coils.
- Nail pop identified.
- Mechanically damaged shingle identified.
- 10 impacts identified on the northwest facing roof slope.
- 12 impacts identified on the southeast facing roof slope.
- This building also inspected a 2nd time, on November 9, 2017 by Tom Irmiter.
The following observations were made at that time:
 - Visible hail damage from hail on roof. No sample squares were done.

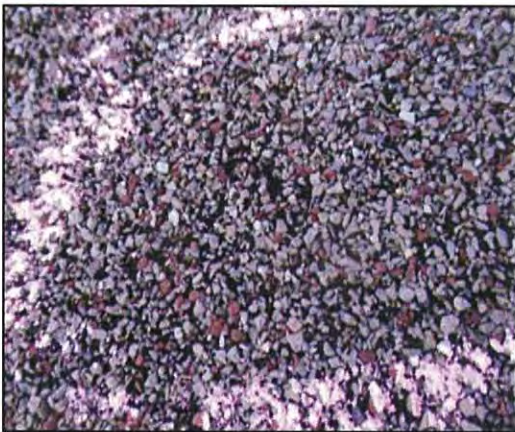
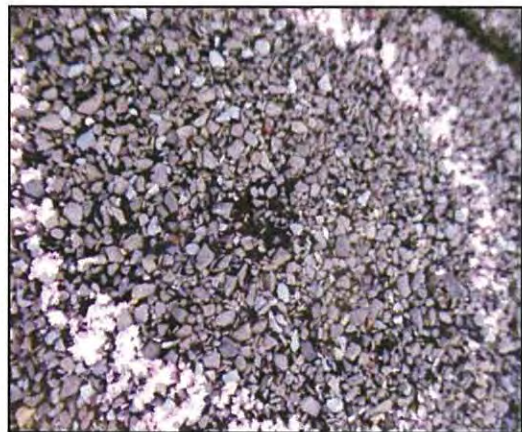
- Impact damage to gutter.
- Impact damage to vinyl siding.
- 20+ impacts identified on the southeast facing roof slope.
- 20+ impacts identified on the northwest facing roof slope.

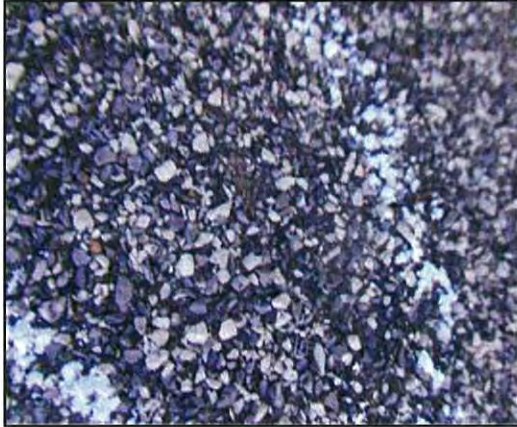
Figure 84.

- Mechanically damaged shingle identified.
- 9 impacts identified on the southwest facing roof slope.
- 9 impacts identified on the northeast facing roof slope.
- This building also inspected a 2nd time, on November 9, 2017 by Tom Irmiter.
The following observations were made at that time:
 - Front: 15 impact locations in 10 x 10 area
 - Back: 16 impact locations in 10 x 10 area

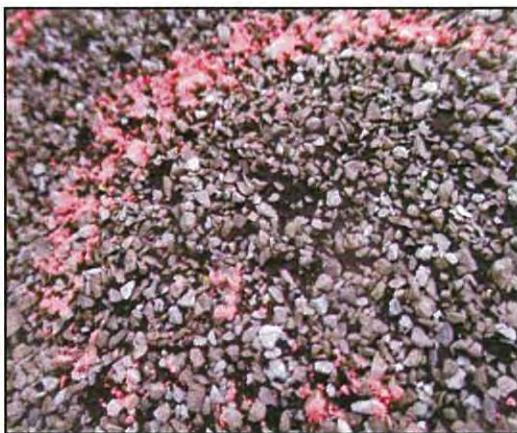
Figure 86.

- Impact damage to gutter.
- Mechanically damaged shingle identified.
- 20+ impacts identified on the northeast facing roof slope.
- 20+ impacts identified on the southwest facing roof slope.
- This building also inspected a 2nd time, on November 9, 2017 by Tom Irmiter.
The following observations were made at that time:
 - Front 10+ impact locations on dormer.

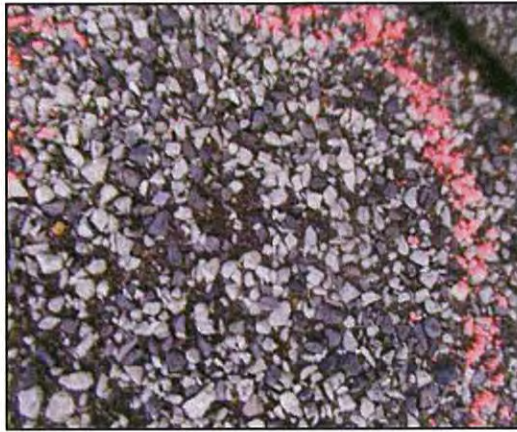
Figure 88.

- Impact damage to gutter.
- 15 impacts identified on the southwest facing roof slope.
- 5 impacts identified on the northeast facing roof slope.

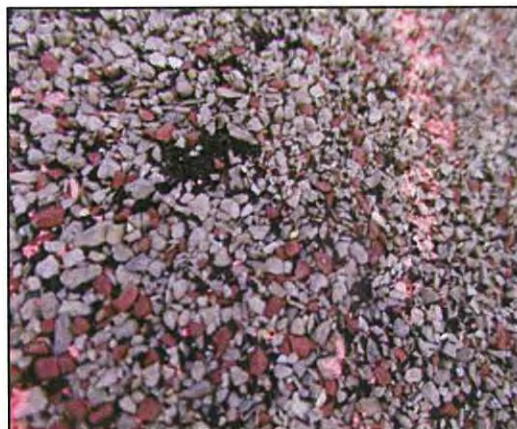
Figure 90.

- Impact damage to gutter.
- Impact damage to vinyl siding.
- Mechanically damaged shingles identified.
- 20+ impacts identified on the east facing roof slope.
- 20+ impacts identified on the west facing roof slope.

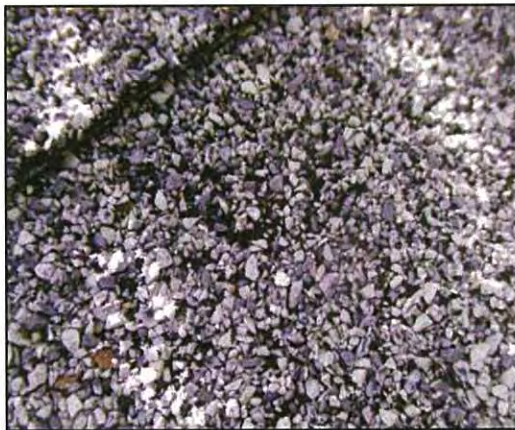
Figure 96.

- Impact damage to gutter and downspouts.
- 10 impacts identified on the southwest facing roof slope.
- 12 impacts identified on the northeast facing roof slope.

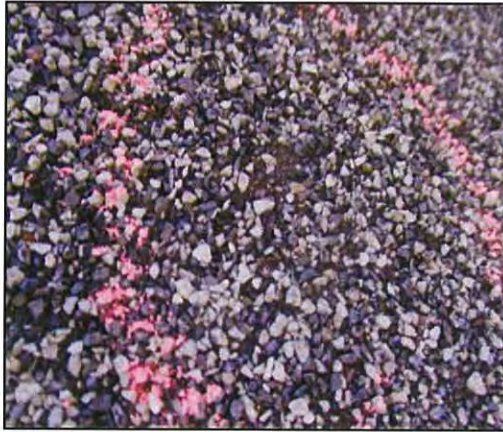
Figure 102.

- This building inspected on October 16, 2017 by Brian Johnson, P.E. and Kevin Steinke. The following observations were made at that time:
- Impact damage to gutter and downspouts.
- Mechanically damaged shingle identified.
- Impact damage to metal flashing identified.
- 13 impacts identified on the east facing roof slope.
- 12 impacts identified on the west facing roof slope.
- This building also inspected a 2nd time, on November 9, 2017 by Tom Irmiter. The following observations were made at that time:
 - Granular loss in gutter.

- Front: 10+ impact marks in 10 x 10 area.
- Back: many impact marks from hail.
- Back: 2 locations with manufacturing/install damage equaling 2 bundles of shingles.

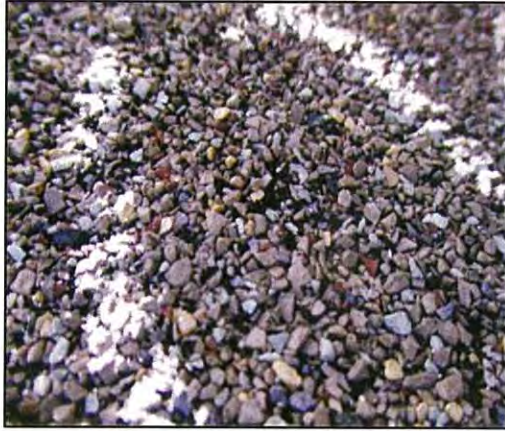
Figure 105.

- Impact damage to gutter.
- 20+ impacts identified on the southwest facing roof slope.
- 20+ impacts identified on the northeast facing roof slope.

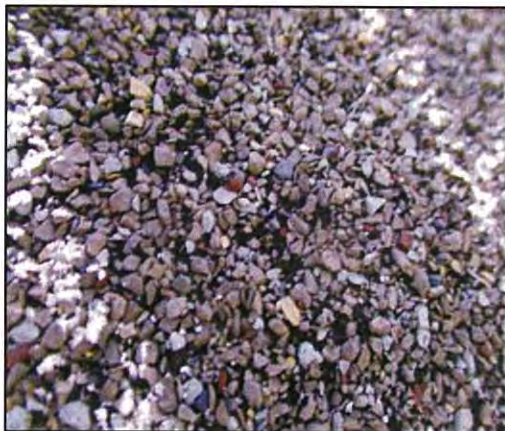
Figure 107.

- Impact damage to gutter and downspout.
- Mechanically damaged shingle identified.
- 20+ impacts identified on the northeast facing roof slope.
- 20+ impacts identified on the southwest facing roof slope.

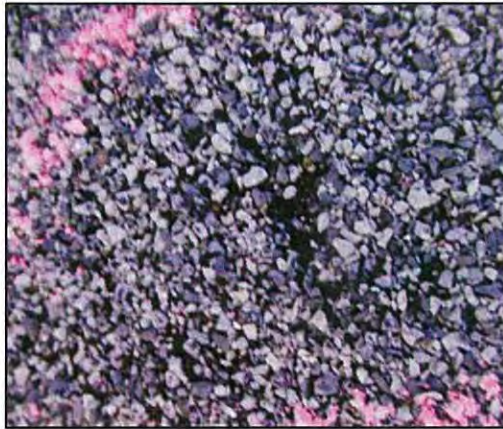
Figure 109.

- Impact damage to gutter.
- 10 impacts identified on the northeast facing roof slope.
- 15 impacts identified on the southwest facing roof slope.

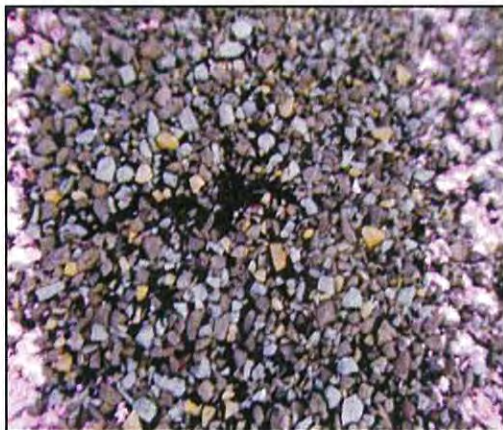
Figure 111.

- Impact damage to gutter.
- Impact damage to metal flashing.
- Roof tarped over in a few areas.
- Replacement shingles identified.
- 20+ impacts identified on the southwest facing roof slope.
- 20+ impacts identified on the northeast facing roof slope.
- This building also inspected a 2nd time, on November 9, 2017 by Tom Irmiter.
The following observations were made at that time:
 - Tarps viewed on roof.
 - Wind damage easily seen from ground.

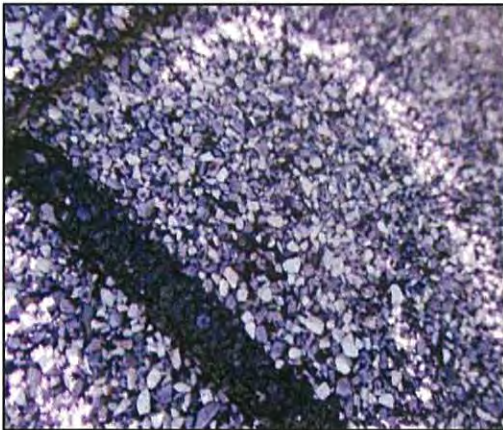
Figure 115.

- This building inspected on October 16, 2017 by Brian Johnson, P.E. and Kevin Steinke. The following observations were made at that time:
- Impact damage to gutter.
- Mechanically damaged shingle identified.
- 20+ impacts identified on the west facing roof slope.
- 20+ impacts identified on the east facing roof slope.

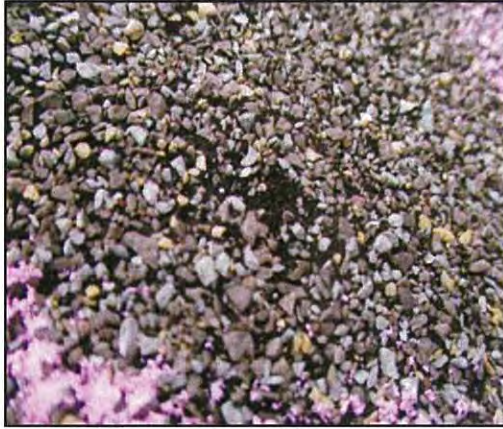
Figure 117.

- Impact damage to gutter and downspouts.
- Detached/displaced piece of vinyl siding.
- 20+ impacts identified on the southwest facing roof slope.
- 20+ impacts identified on the northeast facing roof slope.

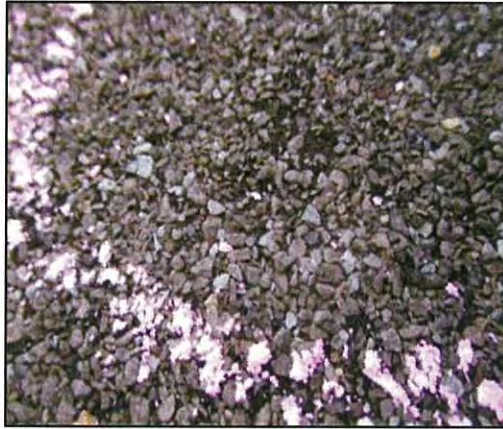
Figure 120.

- Impact damage to gutter and downspouts.
- Impact damage to vinyl siding.
- Detached vinyl siding.
- Mechanically damaged shingle identified.
- 20+ impacts identified on the southeast facing roof slope.
- 13 impacts identified on the northwest facing roof slope.

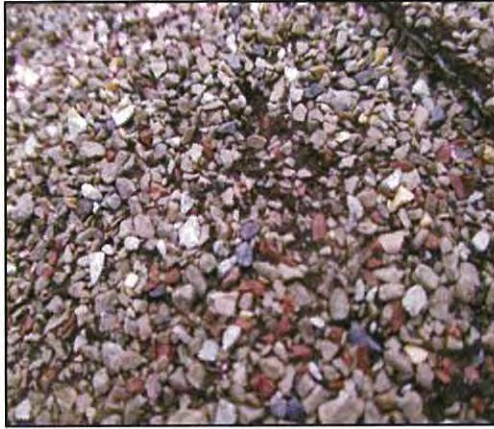
Figure 124.

- Impact damage to gutter and downspout.
- Impact damage to vinyl siding.
- Nail pop identified.
- 20+ impacts identified on the southeast facing roof slope.
- 13 impacts identified on the northwest facing roof slope.

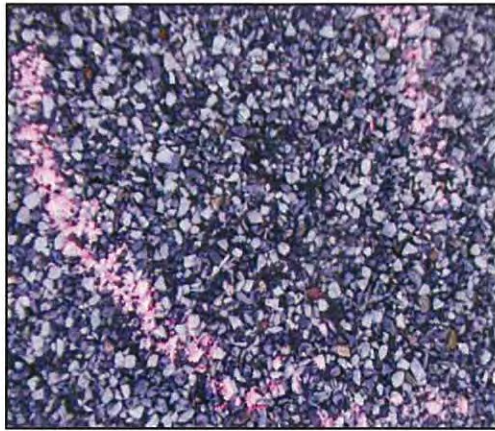
Figure 127.

- Impact damage to gutter and downspout.
- 8 impacts identified on the southwest facing roof slope.
- 10 impacts identified on the northeast facing roof slope.
- This building also inspected a 2nd time, on November 9, 2017 by Tom Irmiter.
The following observations were made at that time:
 - Front: 9 impacts from hail in 10 x 10 area.
 - Back: 9 impacts from hail in 10 x 10 area.

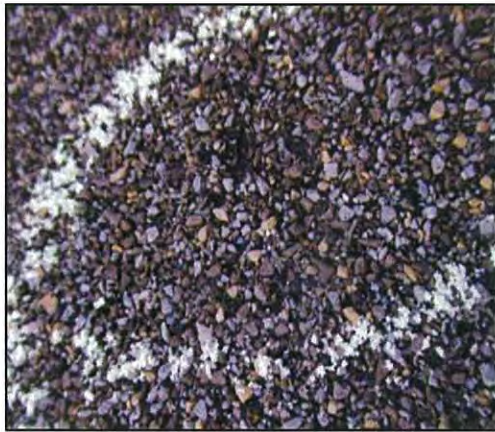
Figure 129.

- Impact damage to gutter.
- Impact damage to vinyl siding.
- Detached vinyl siding.
- 20+ impacts identified on the northwest facing roof slope.
- 20+ impacts identified on the southeast facing roof slope.

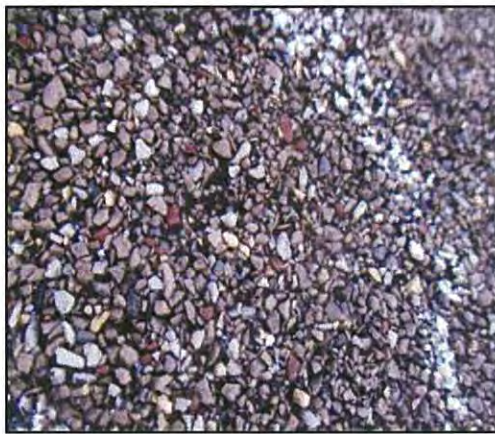
Figure 133.

- Impact damage to gutter.
- Impact damage to vinyl siding.
- 20+ impacts identified on the northwest facing roof slope.
- 20+ impacts identified on the southeast facing roof slope.
- This building also inspected a 2nd time, on November 9, 2017 by Tom Irmiter.
The following observations were made at that time:
 - Front: 14+ impacts from hail in 10 x 10 area.
 - Back: 20+ impacts from hail in 10 x 10 area.

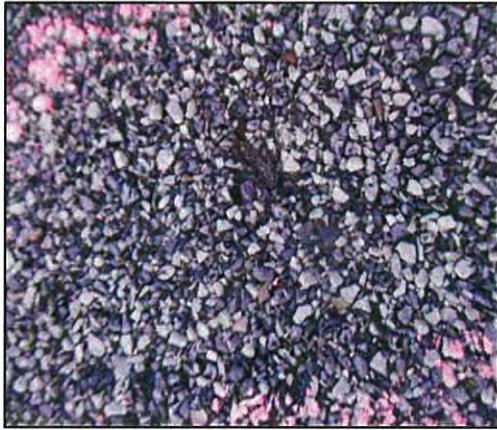
Figure 136.

- Impact damage to gutter.
- Impact damage to vinyl siding.
- 6 impacts identified on the northwest facing roof slope.
- 6 impacts identified on the southeast facing roof slope.

- This building also inspected a 2nd time, on November 9, 2017 by Tom Irmeter. The following observations were made at that time:
 - Front: 15 impacts in 4 x 12 area.
 - Back: total of 3 impacts on entire slope.

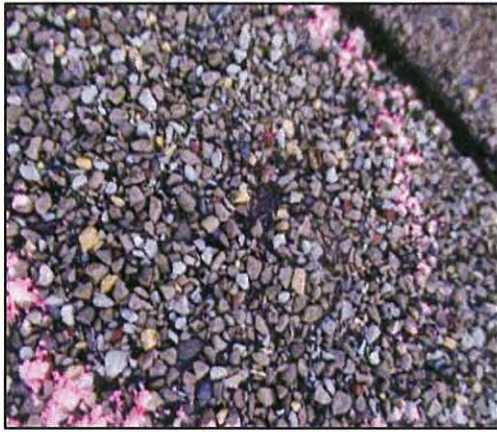
Figure 139.

- Impact damage to gutter and downspout.
- Impact damage to vinyl siding.
- Tarped off sections of roof slopes observed.
- Missing shingle tab identified.
- Detached vinyl siding.
- 20+ impacts identified on the northwest facing roof slope.
- 20+ impacts identified on the southeast facing roof slope.

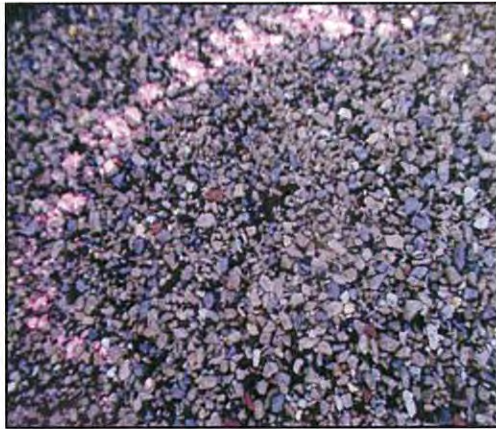
Figure 144.

- Impact damage to gutter.
- Tarped off sections of roof slopes observed.
- Missing shingle tab identified.
- 20+ impacts identified on the southeast facing roof slope.
- 16 impacts identified on the northwest facing roof slope.
